SILVERCREST Monsieur Cuisine Connect SKMC 1200 Blade Socket Replacement

Written By: DafifaD

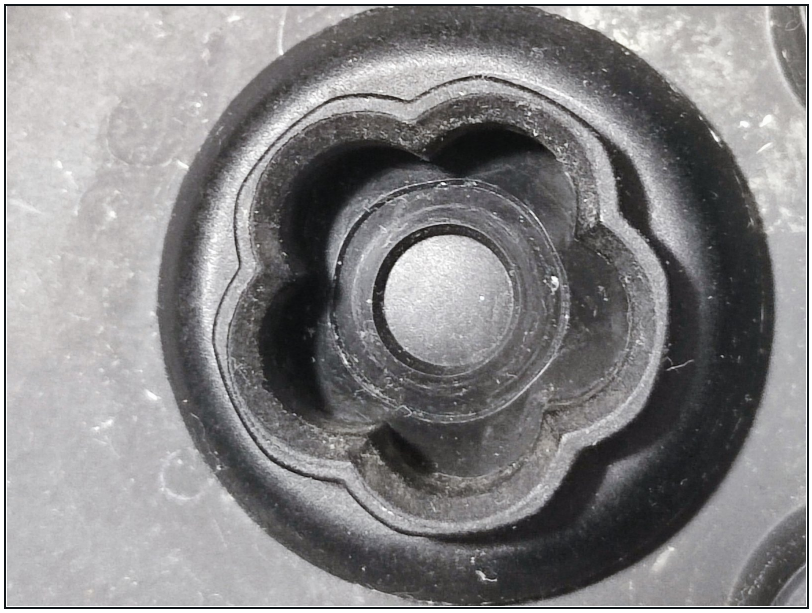
Step 1 — Check part for damage

- Check the external integrity of the blade socket. Then, lift the inner silicone cover by inserting a small flat tool on the inside of the flower's edge and pushing the silicone disc up and towards the center. Once it pops up, you will be able to remove it.

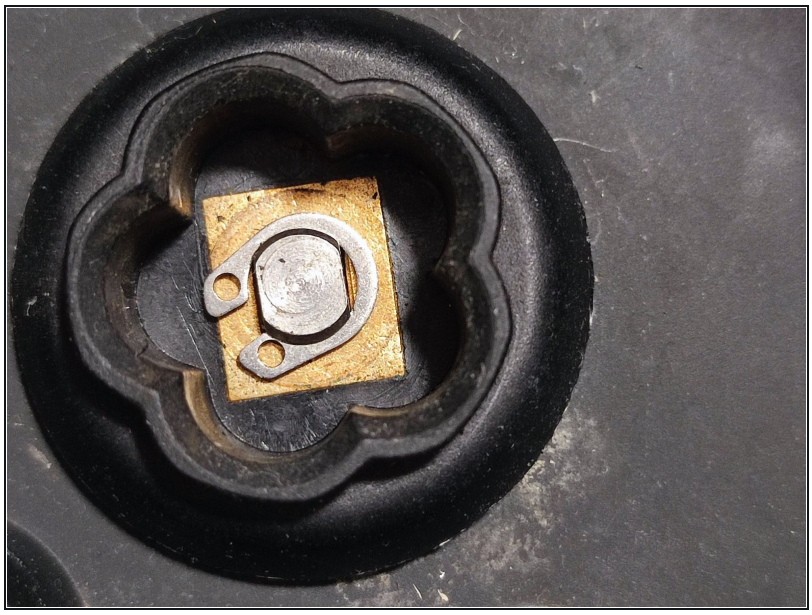
Step 2

- If there is visible damage to either the hard plastic flower or to the metal part in the center it will need to be replaced.
- The spare part is sold at https://shop.monsieur-cuisine.com/es/mon...
- Note: the part shown in the picture has no visible damage and is provided as reference.
